Technical *Info*

Changing the CT 909 K5 timing belt kit for VW/Audi/Skoda/Seat 1.8 T/2.0 to the CT 909 K10

(Change from hydraulic tensioning damper to mechanical tensioning pulley)

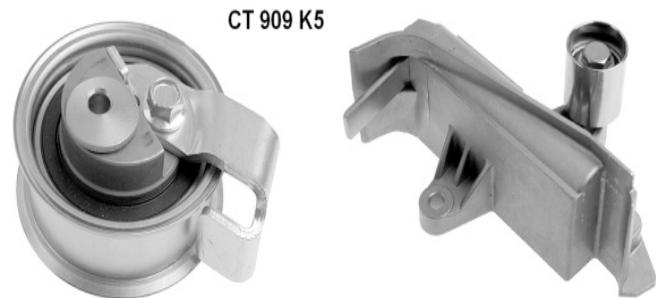
The components supplied in the timing belt kit do not match the components previously installed on the vehicle (Fig. 1).

Fig. 1
Version to be replaced

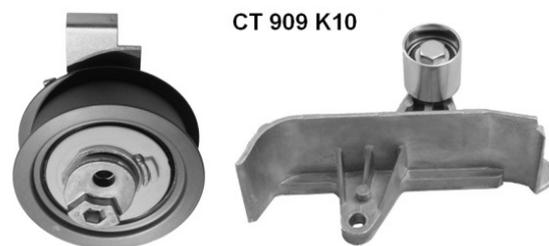
According to the OE manufacturer there is a new tensioning system with a mechanical tensioning pulley for the relevant vehicles specified in the catalogue. In this, the hydraulic tensioning damper with the small idler is replaced by a new version with just one bracket for the idler (Fig. 2).

Fig. 2
New tensioning system
