PRODUCT TECHNICAL INFORMATION

Improvement Camshaft Chain drive for DV5 Stellantis Engine

VKML 83506-1

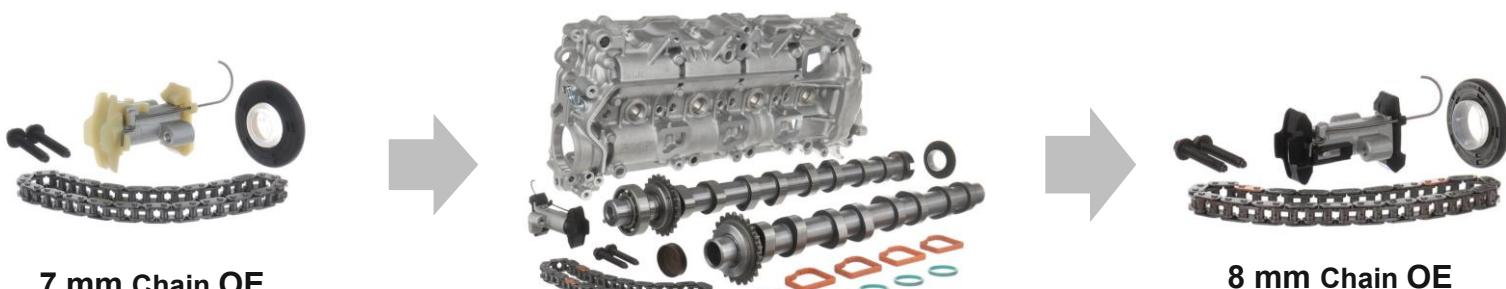
7 mm Chain OE

The issue with Stellantis 1.5 BlueHDi engine is characterized by two symptoms : The first is a rattling noise in the valve train due to play in the camshaft drive chain. The second is a failure to start the engine when the chain breaks, leading to varying degrees of deterioration (bent valves, damaged cylinder head, etc.). In both cases, the chain connecting the two camshafts is the cause.

The improvement proposed by Stellantis and followed by SKF is to move from 7 MM chain to a 8mm chain .

For this improvement , complete conversion kit needs to be used.
