# febiEXAKT

## Chain tensioner

### febi No. 33044

**Opel 2.0l turbo and 2.2l petrol engines**

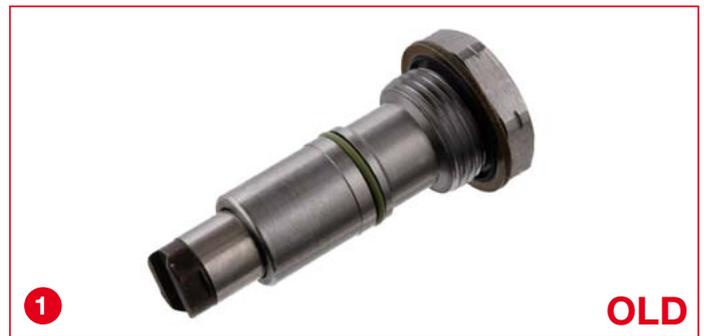
Although all the components have been correctly fitted, rattling noises are often present (caused by the elongation of the timing chain). If the timing chain slips as a result, then the engine can run erratically and misfire and in the worst case cause extensive engine damage. This affects Z22YH and Z22SE engines.

A blocked timing chain tensioner. The original version (repl. no. 0636 549) of the chain tensioner had a green O-ring and a rubber-lined washer (see Fig. 1). The vehicle manufacturer fitted this version in the engines mentioned above. A modified chain tensioner has been used in production since model year 2009.
