SI 0106
For technical personnel only!
1/4

SERVICE INFORMATION

SECONDARY AIR SYSTEM

DESIGN, COMPONENTS, TROUBLESHOOTING

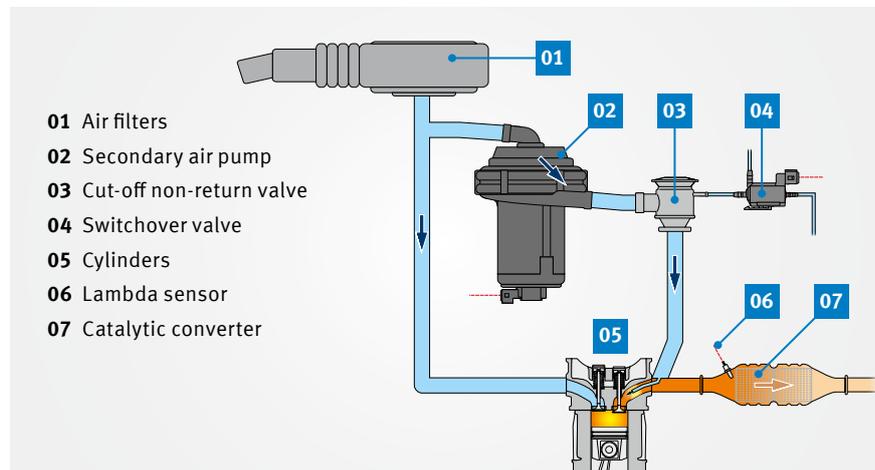
Block diagram of secondary air system (pneumatically actuated)

The secondary-air pump draws in ambient air and injects it into the exhaust manifold downstream of the exhaust valves.

Secondary-air valves are fitted between the secondary-air pump and the exhaust manifold. Use is made of different versions. The secondary-air non-return valve stops exhaust gas, condensate or pressure peaks in the exhaust system (e.g. misfiring) causing damage to the secondary-air pump. The secondary-air shut-off valve ensures that secondary-air is only routed to the exhaust manifold in the cold starting phase. Secondary-air valves are either actuated by a vacuum controlled by a solenoid switching valve or open in response to the pressure of the secondary-air pump.

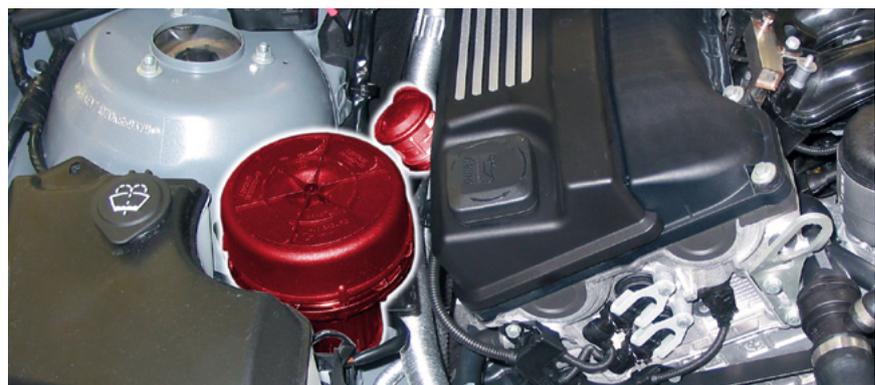
Secondary air valve and secondary air pump in BMW E46 (highlighted)

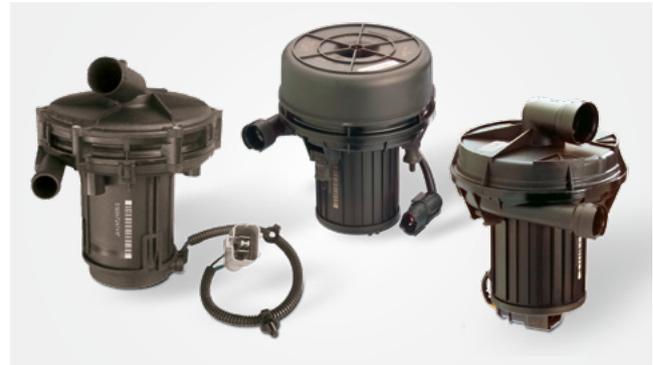
Various 1st and 2nd generation secondary-air pumps

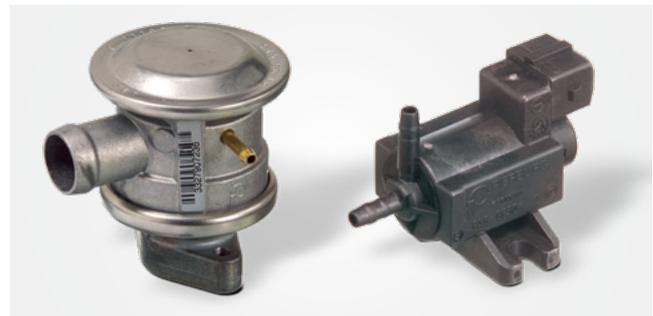
Vacuum-controlled valve with shut-off and non-return function (since approx. 1995) and solenoid switching valve

With more recent generations, the shut-off and non-return functions are combined in one single “secondary-air valve”.

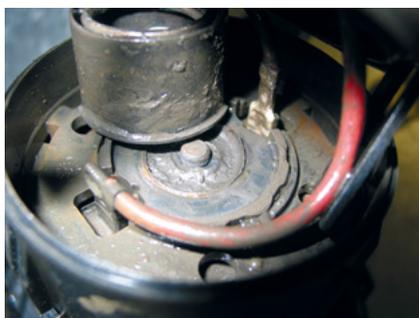
In most of these cases, a defective non-return valve or incorrect actuation of the secondary-air valve has led to exhaust gas condensate ingressing into and damaging the secondary-air pump. The standard remedy is then just to replace the secondary-air pump, which often leads to the same problem occurring again in a short space of time.

Corrosive exhaust gas condensate in the drive motor of a secondary-air pump

- The secondary-air pump must be replaced if it does not run or makes a scraping, whistling or scratching noise during operation.
- In such cases, the other secondary-air system components should also be checked.
- Check for contamination of the engine air filter.
- If the secondary-air is drawn in directly from the engine compartment rather than from the intake system, the separate air filter fitted upstream of the secondary-air pump may be clogged.

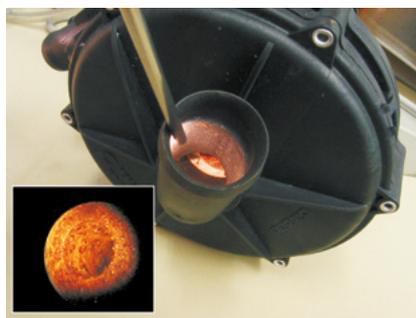
View of the corroded inlet of a secondary-air pump

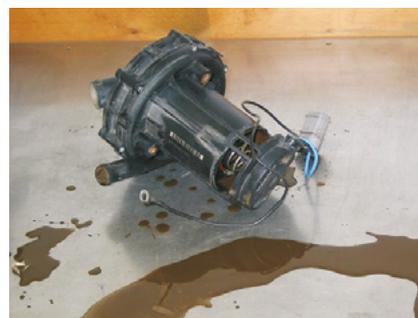
Liquid exhaust gas condensate from a secondary-air pump

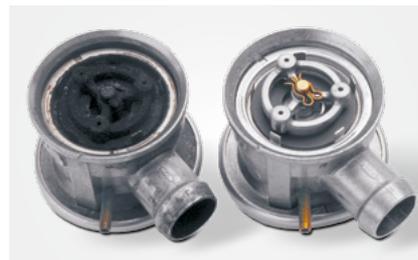
Open secondary air valve
Left: Damage caused by exhaust gas condensate
Right: New condition

- The secondary air valve must be replaced if it does not open on applying vacuum.
- If the secondary air valve opens on applying vacuum, the solenoid actuation valve (switchover valve) and the vacuum hoses must be checked.
- The secondary air valve diaphragm is leaking if the vacuum applied with the vacuum hand pump decreases.
- Deposits on the side facing the secondary air pump (finger test, Fig.) are an indication of non-return valve leakage.
- To check, unfasten the connection hose between the secondary air pump and secondary air valve.

In this case, the secondary air pump may already have suffered damage: Check and, if necessary, replace the secondary air pump.

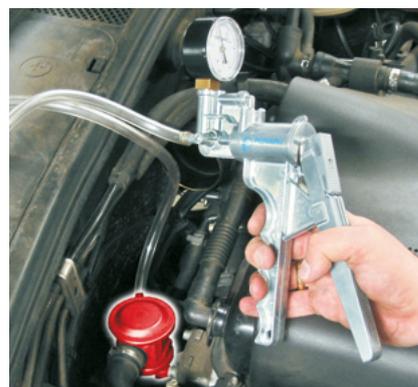
Following removal, operation of a vacuum-controlled secondary air valve can be checked using a vacuum hand pump:

Checking a secondary air valve with a vacuum hand pump

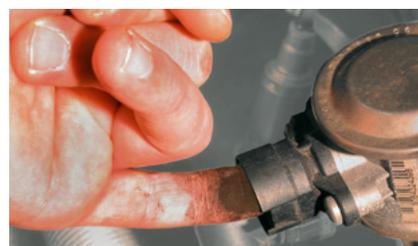
Finger test at secondary air valve in BMW 520i (highlighted)
If deposits are found on this end, the non-return valve is leaking and must be replaced.

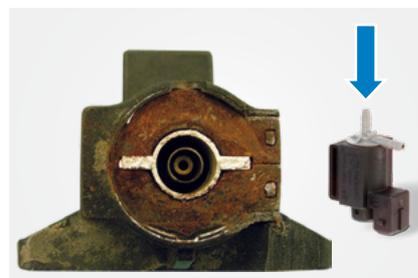
Corroded switchover valve (open)

- A vacuum hand pump can be used to check for opening and leakage.
- During blowing in of secondary air, the on-board voltage must be applied to the plug of the switchover valve. If not, an electrical fault has occurred and must be localised with the help of a circuit diagram.
