# Ford Transit Clutch Replacement

The Transit featured in this article is a 2002 350 long-wheelbase tipper model which was still putting in many hard days of work after 160,000 miles (260,000km). However, a 'rattling'/knocking noise was reported to be coming from the clutch area, and an oil leak was discovered between the engine and the transmission. This was possibly due to a faulty dual-mass flywheel and a leaking engine rear-main oil seal, which would require the gearbox to be removed along with the clutch assembly and flywheel. A full inspection would be necessary to diagnose the fault and rectify it.

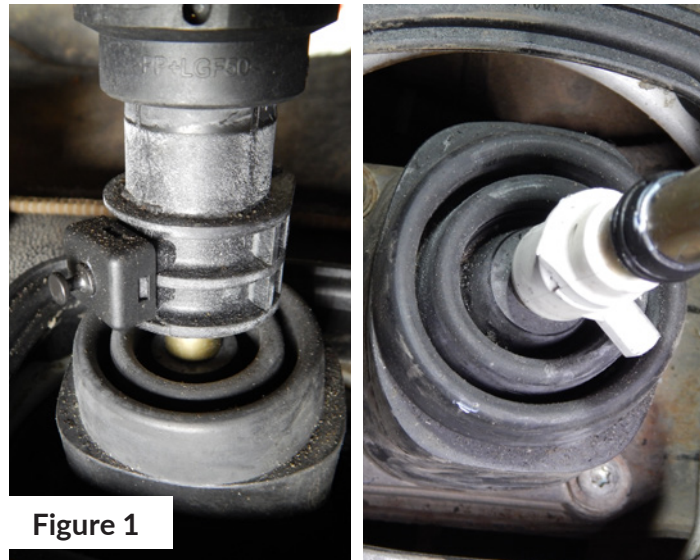
Figure 1

The Transit featured here is a rear-wheel drive variant equipped with the 2.4 TDCi diesel engine. Therefore, to begin the gearbox-removal process, the first job is to remove the gear stick from inside the cab by removing the rubber gaiter and sound insulation around the gear stick (in the 'neutral' position), followed by releasing the plunger on the gear stick extension to 'free' it from the lower part. Then, take out the four retaining bolts to the transmission, which will allow the gear stick to be completely removed. (Fig.1)

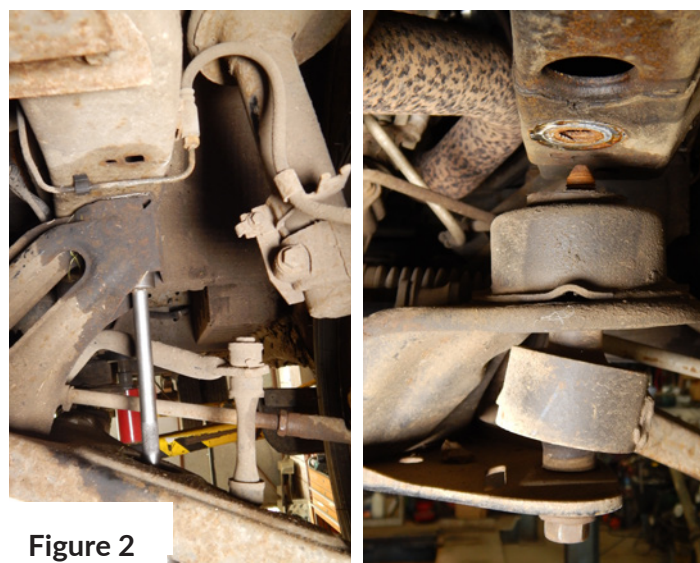
Figure 2

Partially remove the retaining bolts that fix the rear of the crossmember to the chassis, then loosen the front-fixing bolts but do not remove them completely. This results in the crossmember being lowered to give enough clearance for the transmission to be removed from the vehicle. (Fig.2)

The crossmember, which is also the fixing point for the front steering and suspension components, needs to be lowered but not removed completely. This is to allow enough room for the transmission to pass.

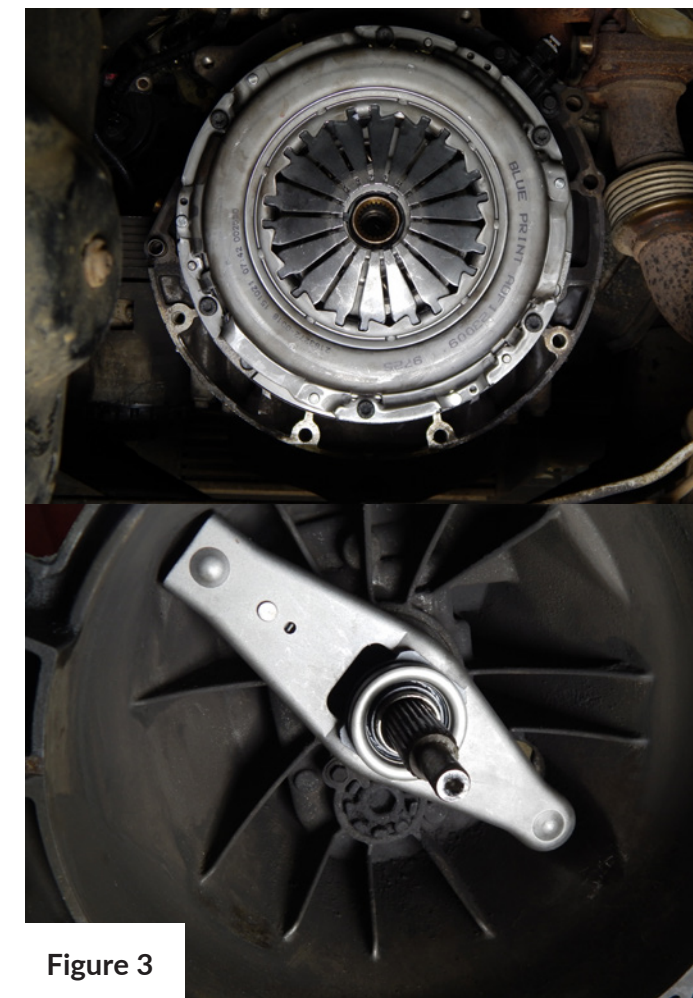
Figure 3

Before fitting the new pressure plate and disc, clean the contact surfaces and align and fit all parts fully against the flywheel - along with the new retaining bolts. Tighten the six pressure plate bolts diagonally to ensure 'even' contact and to prevent any damage to the pressure plate and flywheel-centering pins. (Fig.3)

Attention then turns to the release mechanism. Thoroughly clean the bell housing to eliminate all grease, dirt and old friction fibres from the previous clutch. Then, remove the release fork and inspect it for cracks and/or wear. (Fig.3)

Clip the new release bearing into the new release fork, then test the operation of the release mechanism for smoothness. Lightly apply some grease to the input shaft - now, the transmission is ready to be refitted to the engine.
