Citroën Berlingo Clutch Replacement

The focus of this article is a 2007 Citroen Berlingo, fitted with the 1.6 litre HDi engine, the clutch had been reported to slip and required replacement.

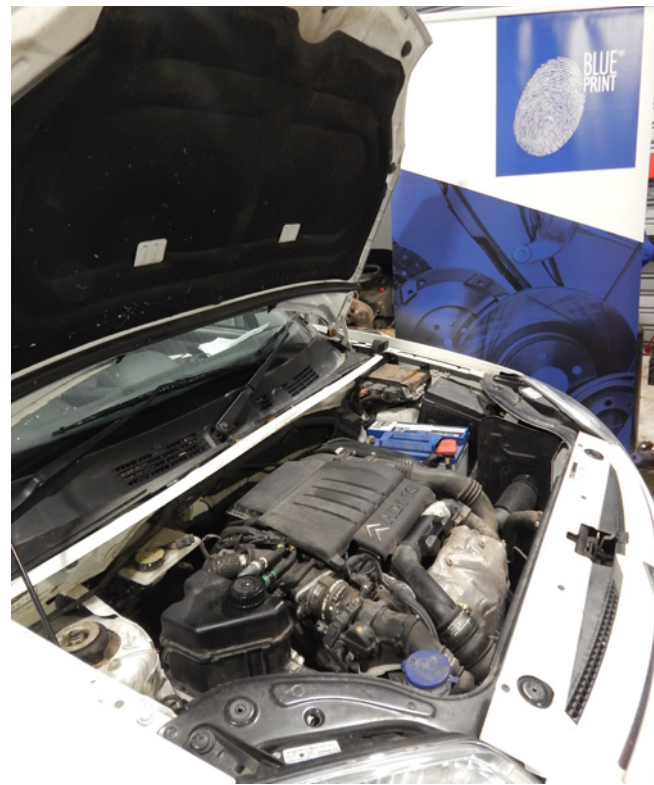
With the bonnet open, the engine cover and air inlet duct were removed along with disconnecting and removing the battery and battery tray. This allowed access to disconnect the reverse lamp switch and earth cable from the gearbox, along with unbolting the water heater. This was followed by releasing the gear selector rods from the selector mechanism. (Fig. 1)

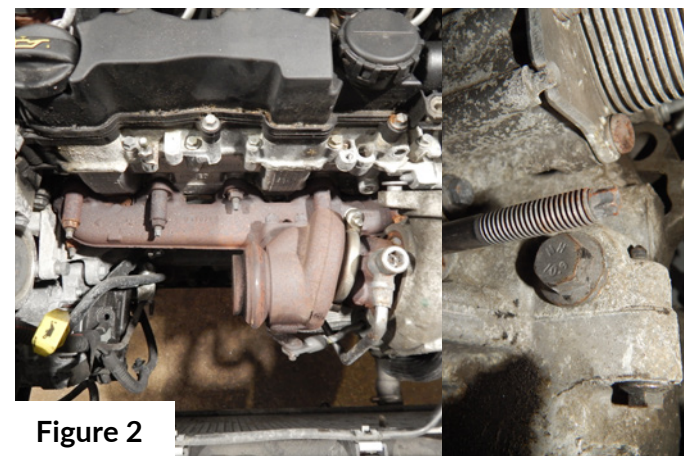
Figure 2

removing the catalytic converter, which has a very limited access for removal. First, a sheet of cardboard was placed between the radiator and the catalytic converter to protect the radiator from damage. Then all the heat shield bolts were removed, followed by the removal of the fixing clamps to the exhaust and the turbo. Then the catalyst and the heat shields were carefully removed, revealing the bolt and stud, that required removal. (Fig.2)

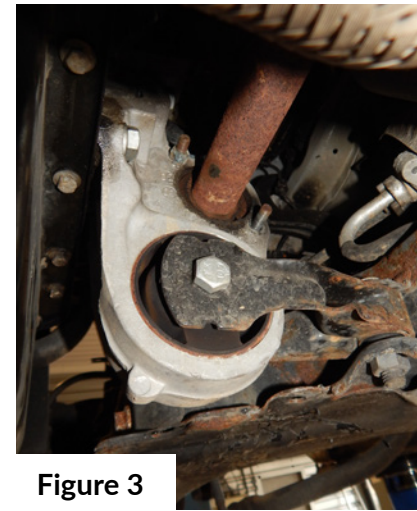
Figure 3

Remove the left drive shaft from the vehicle, then unbolt and remove the torque reaction rod, attached to the rear lower engine mount. Then unbolt the retaining bolts for the right driveshaft support bearing and remove the right driveshaft. (Fig 3) Note: It is advisable to replace the driveshaft oil seals before refitting the transmission.

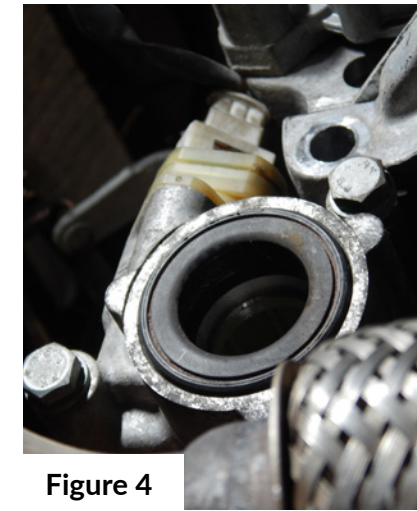
Figure 4

Our attention then turned, to the release mechanism; the bell housing was thoroughly cleaned to free all grease, dirt, and old friction fibres from the previous clutch, and then the release fork was removed and inspected for cracks or wear. This fork has a plastic pivot, which is prone to cracking, and was closely

inspected and greased before refitting, along with the release bearing guide sleeve, which is also prone to wear, over time. If both parts are required, these are available within the Blue Print range.

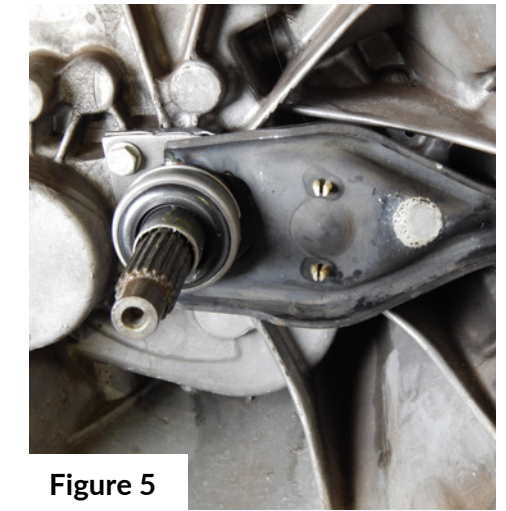
Figure 5

The release bearing was clipped, into the fork and then operation of the release mechanism tested for smoothness, before lightly applying grease on to the input shaft. The transmission was now ready to be refitted to the engine. (Fig. 5)
