# Sekundärluftpumpe zu lange angesteuert

## Technische Information für die Werkstatt

# Secondary air pump – excessive activation time

## Technical Information for Workshops

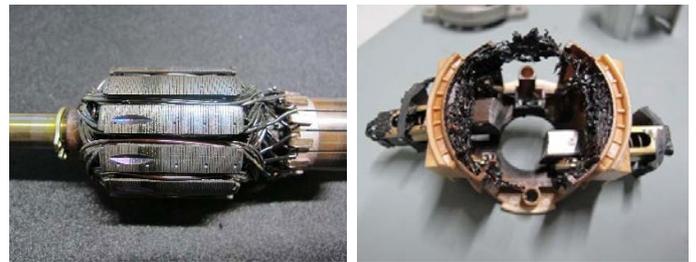
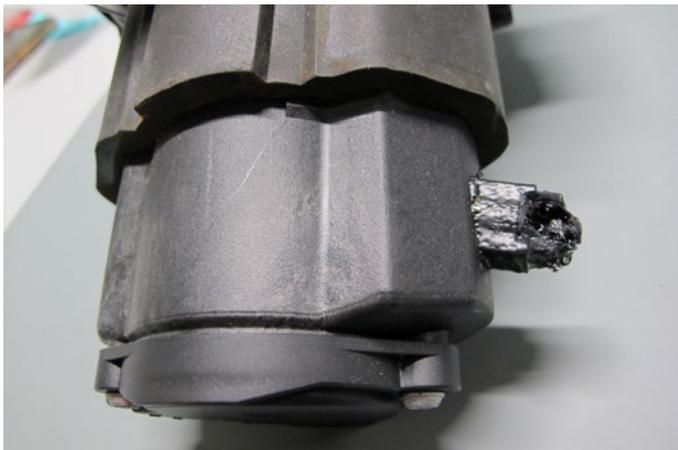
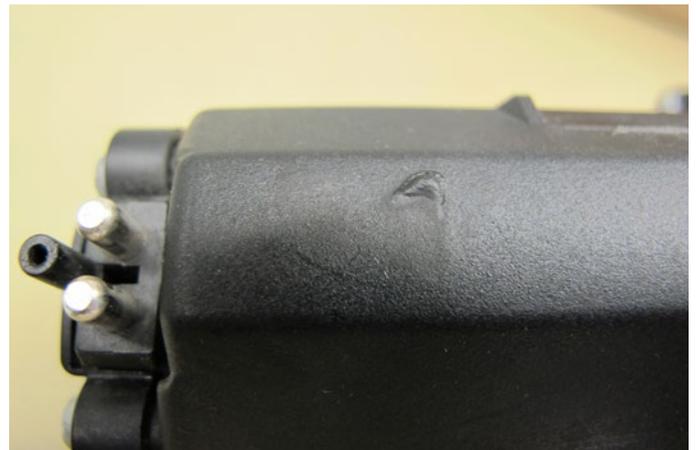
- ▶ Motorkontrolleuchte AN, Fehlercode in Bezug zum Sekundärluftsystem
- ▶ Sekundärluftpumpe läuft nicht (bei Ansteuerung)
- ▶ Schmelzspuren an der Sekundärluftpumpe
- ▶ Schmorgeruch an der Sekundärluftpumpe
- ▶ schleifende/kratzende Geräusche bei aktiver Sekundärluftpumpe

Defektes/verklebtes/klemmendes Ansteuer-Relais der Sekundärluftpumpe.

Bei Kaltstart ist eine Ansteuerdauer der Sekundärluftpumpe von ca. 60 Sekunden üblich, bei sehr niedriger Umgebungstemperatur von max. 120 Sekunden. Eine längere Belastung verkürzt die Lebensdauer oder führt direkt zum Ausfall.

Die Fotos zeigen eine zerlegte Sekundärluftpumpe mit Überhitzungs- und Schmelzspuren.

Bei sichtbaren Schmelzspuren am Gehäuse oder im Bereich der elektrischen Steckkontakte sowie bei Schmorgeruch an der Sekundärluftpumpe wird empfohlen:

- ▶ das Sekundärluftpumpen-Relais vorsorglich zu tauschen
- ▶ weitere Ursachen für den vorzeitigen Ausfall der Sekundärluftpumpe zu prüfen

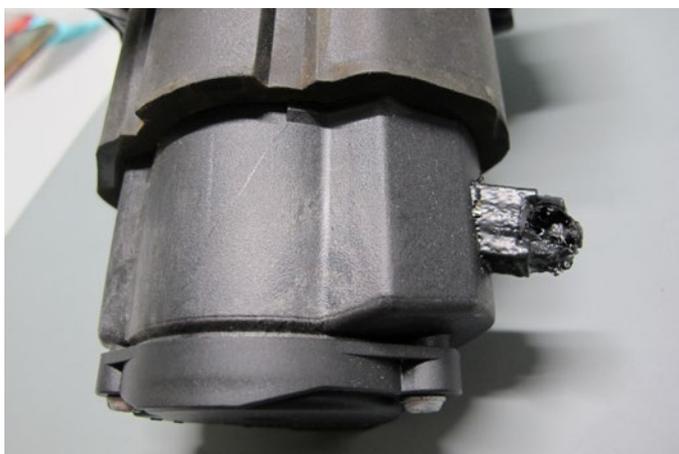
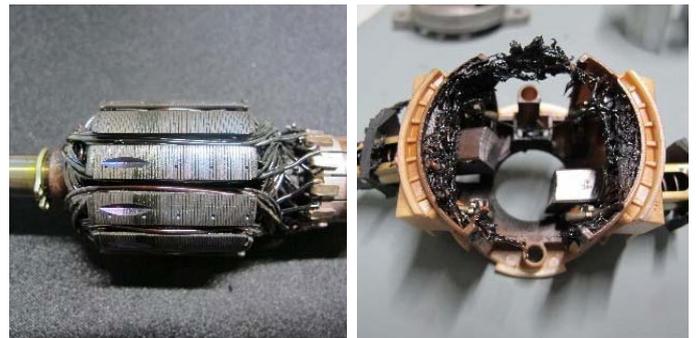
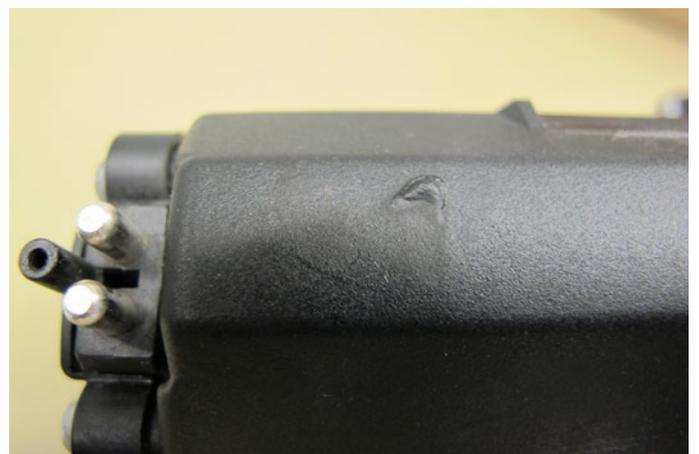
- ▶ engine control light ON, error code related to secondary air system
- ▶ secondary air pump fails to run (when activated)
- ▶ melt marks on the secondary air pump
- ▶ smouldering smell from the secondary air pump
- ▶ rubbing/scratching noises when secondary air pump is active

Control relay of secondary air pump defective, stuck or jammed.

At cold start, the secondary air pump is commonly activated for approx. 60 seconds (or 120 seconds max. at very low ambient temperatures). Longer periods of activation will shorten the service life or lead directly to a complete failure of the pump.

The photographs depict a disassembled secondary air pump with traces of overheating and melt marks.

If there are visible signs of melting on the housing or in the area of the electrical plug contacts, or if a smouldering smell is perceptible from the secondary air pump, the following procedure is recommended:

- ▶ replace the secondary air pump relay (as a precautionary measure)
- ▶ check for other possible causes of premature failure of the secondary air pump
