**PI 1904**

## WARNING ABOUT PRODUCT FAKES

### FOR THE VARIABLE INTAKE MANIFOLD ON THE MERCEDES-BENZ M272

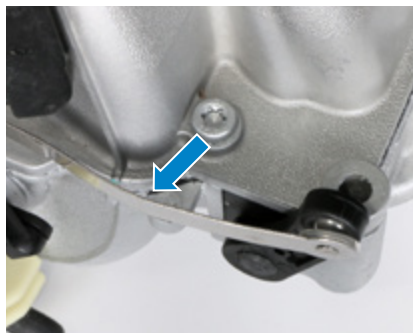
Fig. 3

- "... thin sheet on the cam control mechanism, which bends after a relatively short time (Fig. 3)."
- "The lever springs out of its mounting (Fig. 4).  
This incorrectly actuates the flap position sensor and can lead to an error message."
- "The flap bearings can break." (Fig. 5)
- "Parts can come loose." (Fig. 6)
- "The linkage makes noises that can clearly be heard during vehicle operation."
- "Installation of these fakes would represent gross negligence."

The cause that leads to the cam control mechanism breaking and remedy instructions can be found in our Service Information SI 1455.
