SERVICEINFORMATION

SIMPLE FAULT CAUSES ARE OFTEN MISSED

OBD ERROR DUE TO INADEQUATE VACUUM

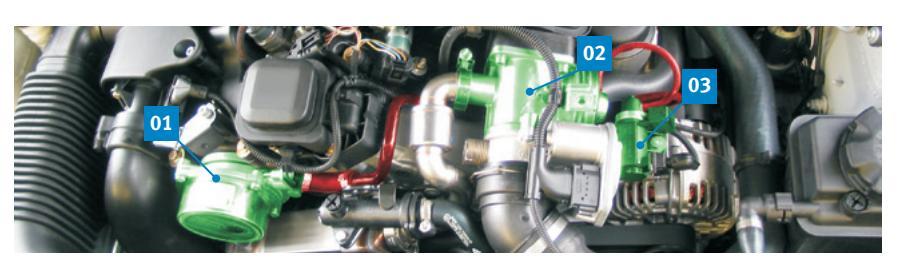
Example BMW 118d (E87): Components in the vacuum system (green), vacuum hoses (red)

- 01 vacuum pump 02 EGR valve
- **03** electro-pneumatic pressure transducer

In the event of a malfunction, check the leak tightness of all components in the vacuum system and replace the failed part.
